**BMW 2002tii**  
Run by David Evans  
Owned since May 2000  
Total mileage (2)60,072  
Miles since September report four  
Latest costs £4201

## FACELIFT MAKES LPB LOOK OLDER

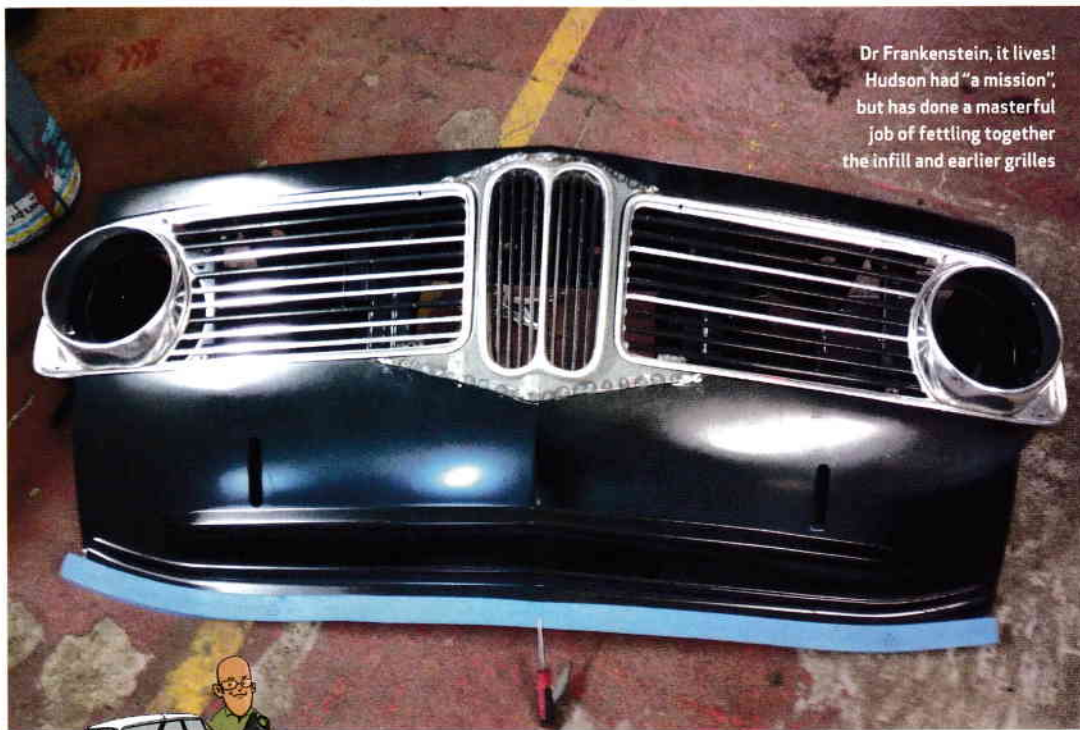
Dr Frankenstein, it lives!  
Hudson had "a mission",  
but has done a masterful  
job of fettling together  
the infill and earlier grilles

Now I was rubbish at metalwork, but even I can appreciate the sheer amount of craft that John has put into cutting down the infill piece and then fettling it into place. That

was at the same time as calculating exactly where it needed to go so that the grilles would fit properly. Plus, he had to gently massage them back into the correct shape using a new one as a guide.

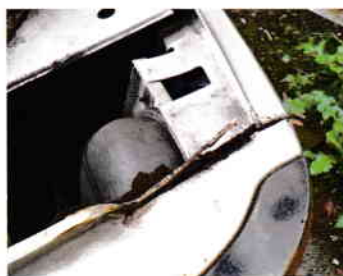
Corroded front wing seam had turned ugly

Luckily, my other long-suffering chum Brian Buckett came to the rescue with some tidy second-hand grilles. He also had a good offside front wing to replace the one that was rapidly going the same way as the front panel. I had kindly been given a new pattern wing, but it was significantly shorter than a factory BMW item and would have left a quarter-inch gap to the door.

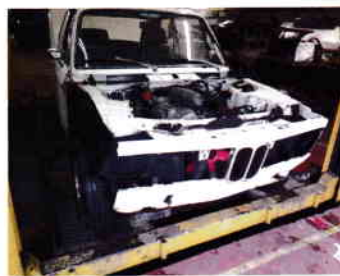
No more wrong front end gags, Gromit...

The old front panel didn't put up much resistance – most of the lower valance crumbled – and, once he was into the shell proper, Hudson discovered more areas of corrosion. A hole in the bulkhead had allowed water to get in under the carpet.

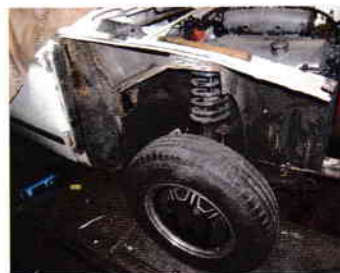
Hole in bulkhead had let water into cabin

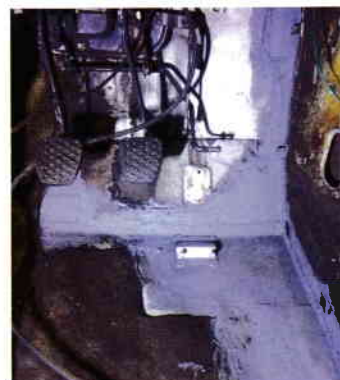
As John put it: "The floor was a bit crusty around the accelerator pedal bracket [he fabricates those], and water had gone into the chassis rail." The jacking point nearby was solid, unlike the soft metal beneath it. It also needed a new wing mounting band where one had been laid on top of the original on that side.

Repaired floor, with new throttle bracket

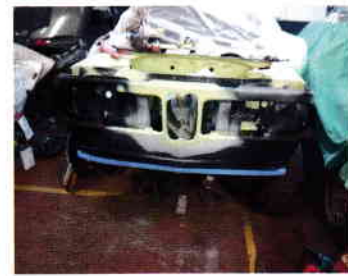
...the 'new' old one is now welded in place

Johnno also found that, despite it being a BMW Classic part, the new front panel was a full 12mm out on one side, so he had to unpick the welds and correctly realign it.

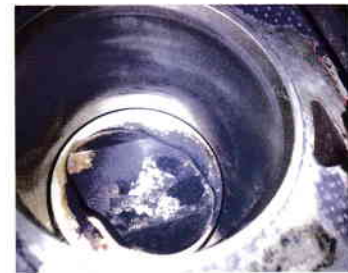
Next up was the engine, which, with the ancillaries, stretched timing chain and head off, revealed polished bores and a peculiar mark on number 4. I bought a new chain from WN and Johnno put me in touch with Steve Nelson at Top End Performance in the States for a new set of piston rings. Hudson has also been tidying up the engine bay, letting in repairs to both longerons and the nearside strut top. I've suggested the same rule of thumb with John as I did with Rob Moss at

Odd radial mark but no step on number 4
